# Japan's Fukushima nuclear plant begins fuel rod removal

## Fukushima nuclear plant set for risky operation

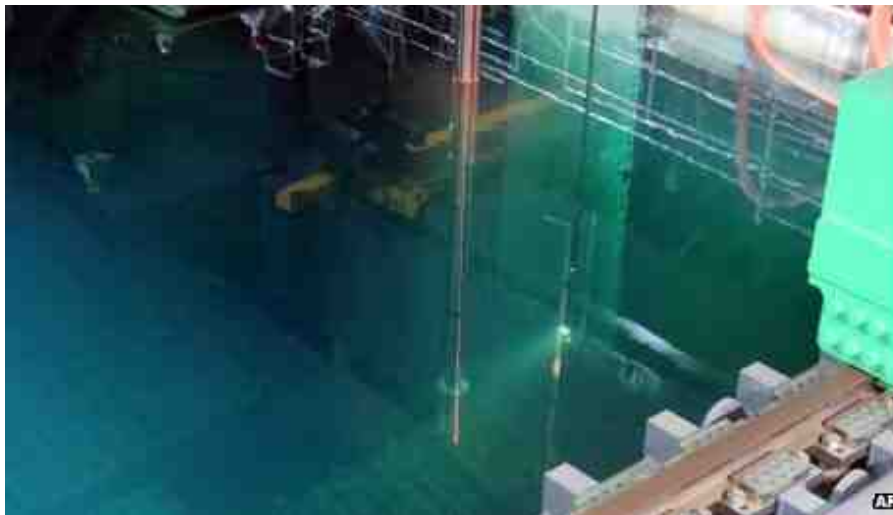
AFP Removal of fuel

rods from the storage pond is a key step in the decommissioning

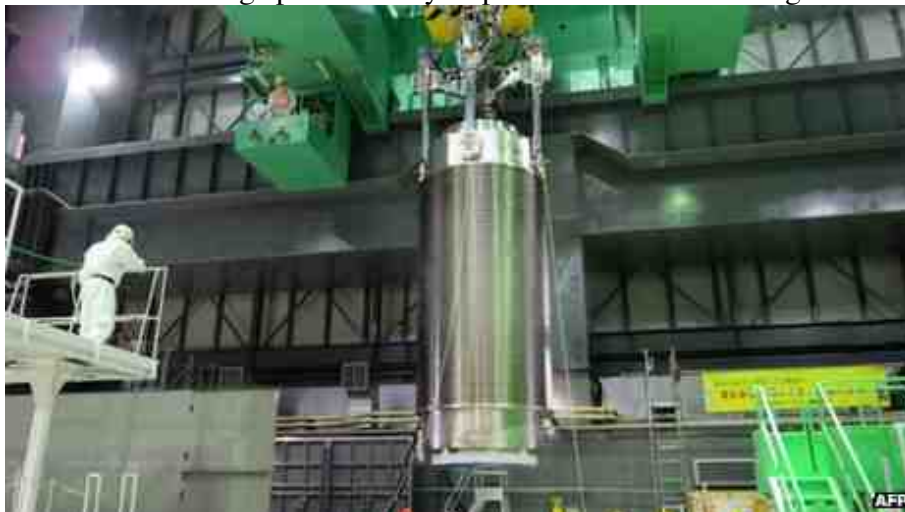
AFP Tepco has conducted

trial runs of the process, which involves large casks

A recently-installed crane is being lowered into the pool and hooked onto the assemblies to place them inside a cask.

Experts say it is vital that the casks are watertight so the rods have no contact with air - which

risks overheating and possible contamination.

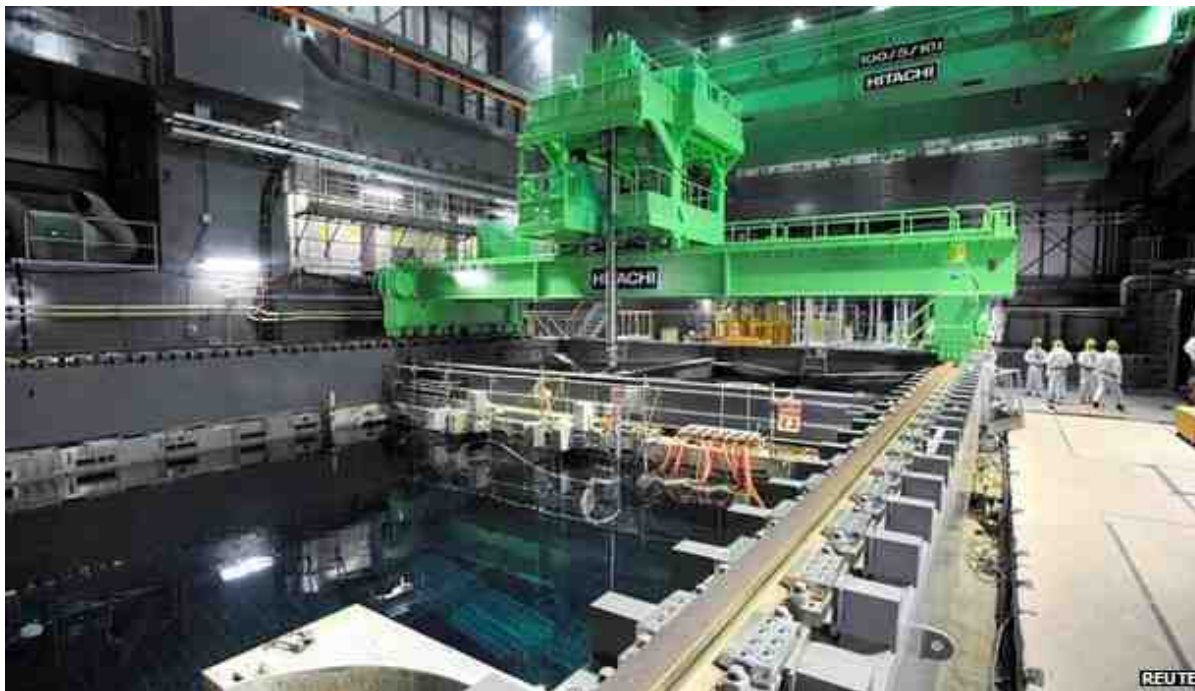
More than 1,000 fuel rod assemblies need to be removed from a building that was badly damaged following the tsunami
